Baseline Environmental Assessment Submittal Form

Street Address of Property: 1600 West Eight Mile Road City: Ferndale State: MI Zip: 48220 Property Tax ID (include all applicable IDs): 25-33-451-003; 25-33-451-005 Address according to tax records, if different than above (include all applicable addresses): City: State: Zip: Status of submitter relative to the property (check all that apply): Owner Former <input type="checkbox"/> Current <input checked="" type="checkbox"/> Prospective <input type="checkbox"/> Operator Former <input type="checkbox"/> Current <input type="checkbox"/> Prospective <input type="checkbox"/>	County: Oakland City/Village/Township: Ferndale Town: 1N Range: 11E Section: 33 Quarter: SE Quarter-Quarter: SW/NW Decimal Degrees Latitude: 42.4480 Decimal Degrees Longitude: -83.1490 Reference point for latitude and longitude: Center of site <input checked="" type="checkbox"/> Main/front door <input type="checkbox"/> Front gate/main entrance <input type="checkbox"/> Other <input type="checkbox"/> Collection method: Survey <input type="checkbox"/> GPS <input type="checkbox"/> Interpolation <input checked="" type="checkbox"/>

Photographs From Site Reconnaissance
PM P

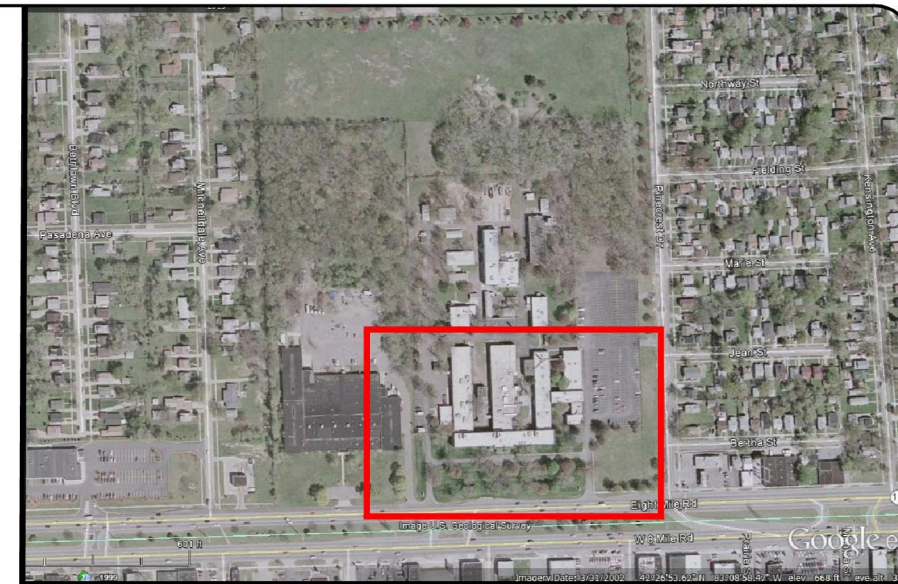
FIGURE 4
ZOOMED IN SECTION OF FORMER SOUTHERN BUILDINGS

E	OFFICES, AUTO APP. DEPARTMENT
F	MAINTENANCE AND SERVICES
G	ANALYTICAL LAB
AL	VEHICLE FUELING
A	EXECUTIVE OFFICES
B	EXPERIMENT, MACHINE SHOP, GARAGE AND REF. TECHNICIAN
C	ENGINE RES. AND DYNAMOMETER
D	CHEMICAL LAB, LIBRARY, PHOTO AND FILES
DA	CHEMICAL RES., EXECUTIVE OFFICES AND PLANT
DAN	CHEMICAL RES. LAB
DAS	AUDITORIUM
BA	SHIPPING AND RECEIVING, AND COMPUTERS
H	FUEL BLENDING
Q	GUARD SHACK

The subject property location is depicted on Figure 1, Site Location Map. A diagram of the subject property and adjoining properties is included as Figure 2, Generalized Diagram of the Subject Property and Surrounding Area. A diagram of the historical layout of the property is included as Figure 3 and Figure 4. Photographs taken during the site reconnaissance are included in Appendix A.

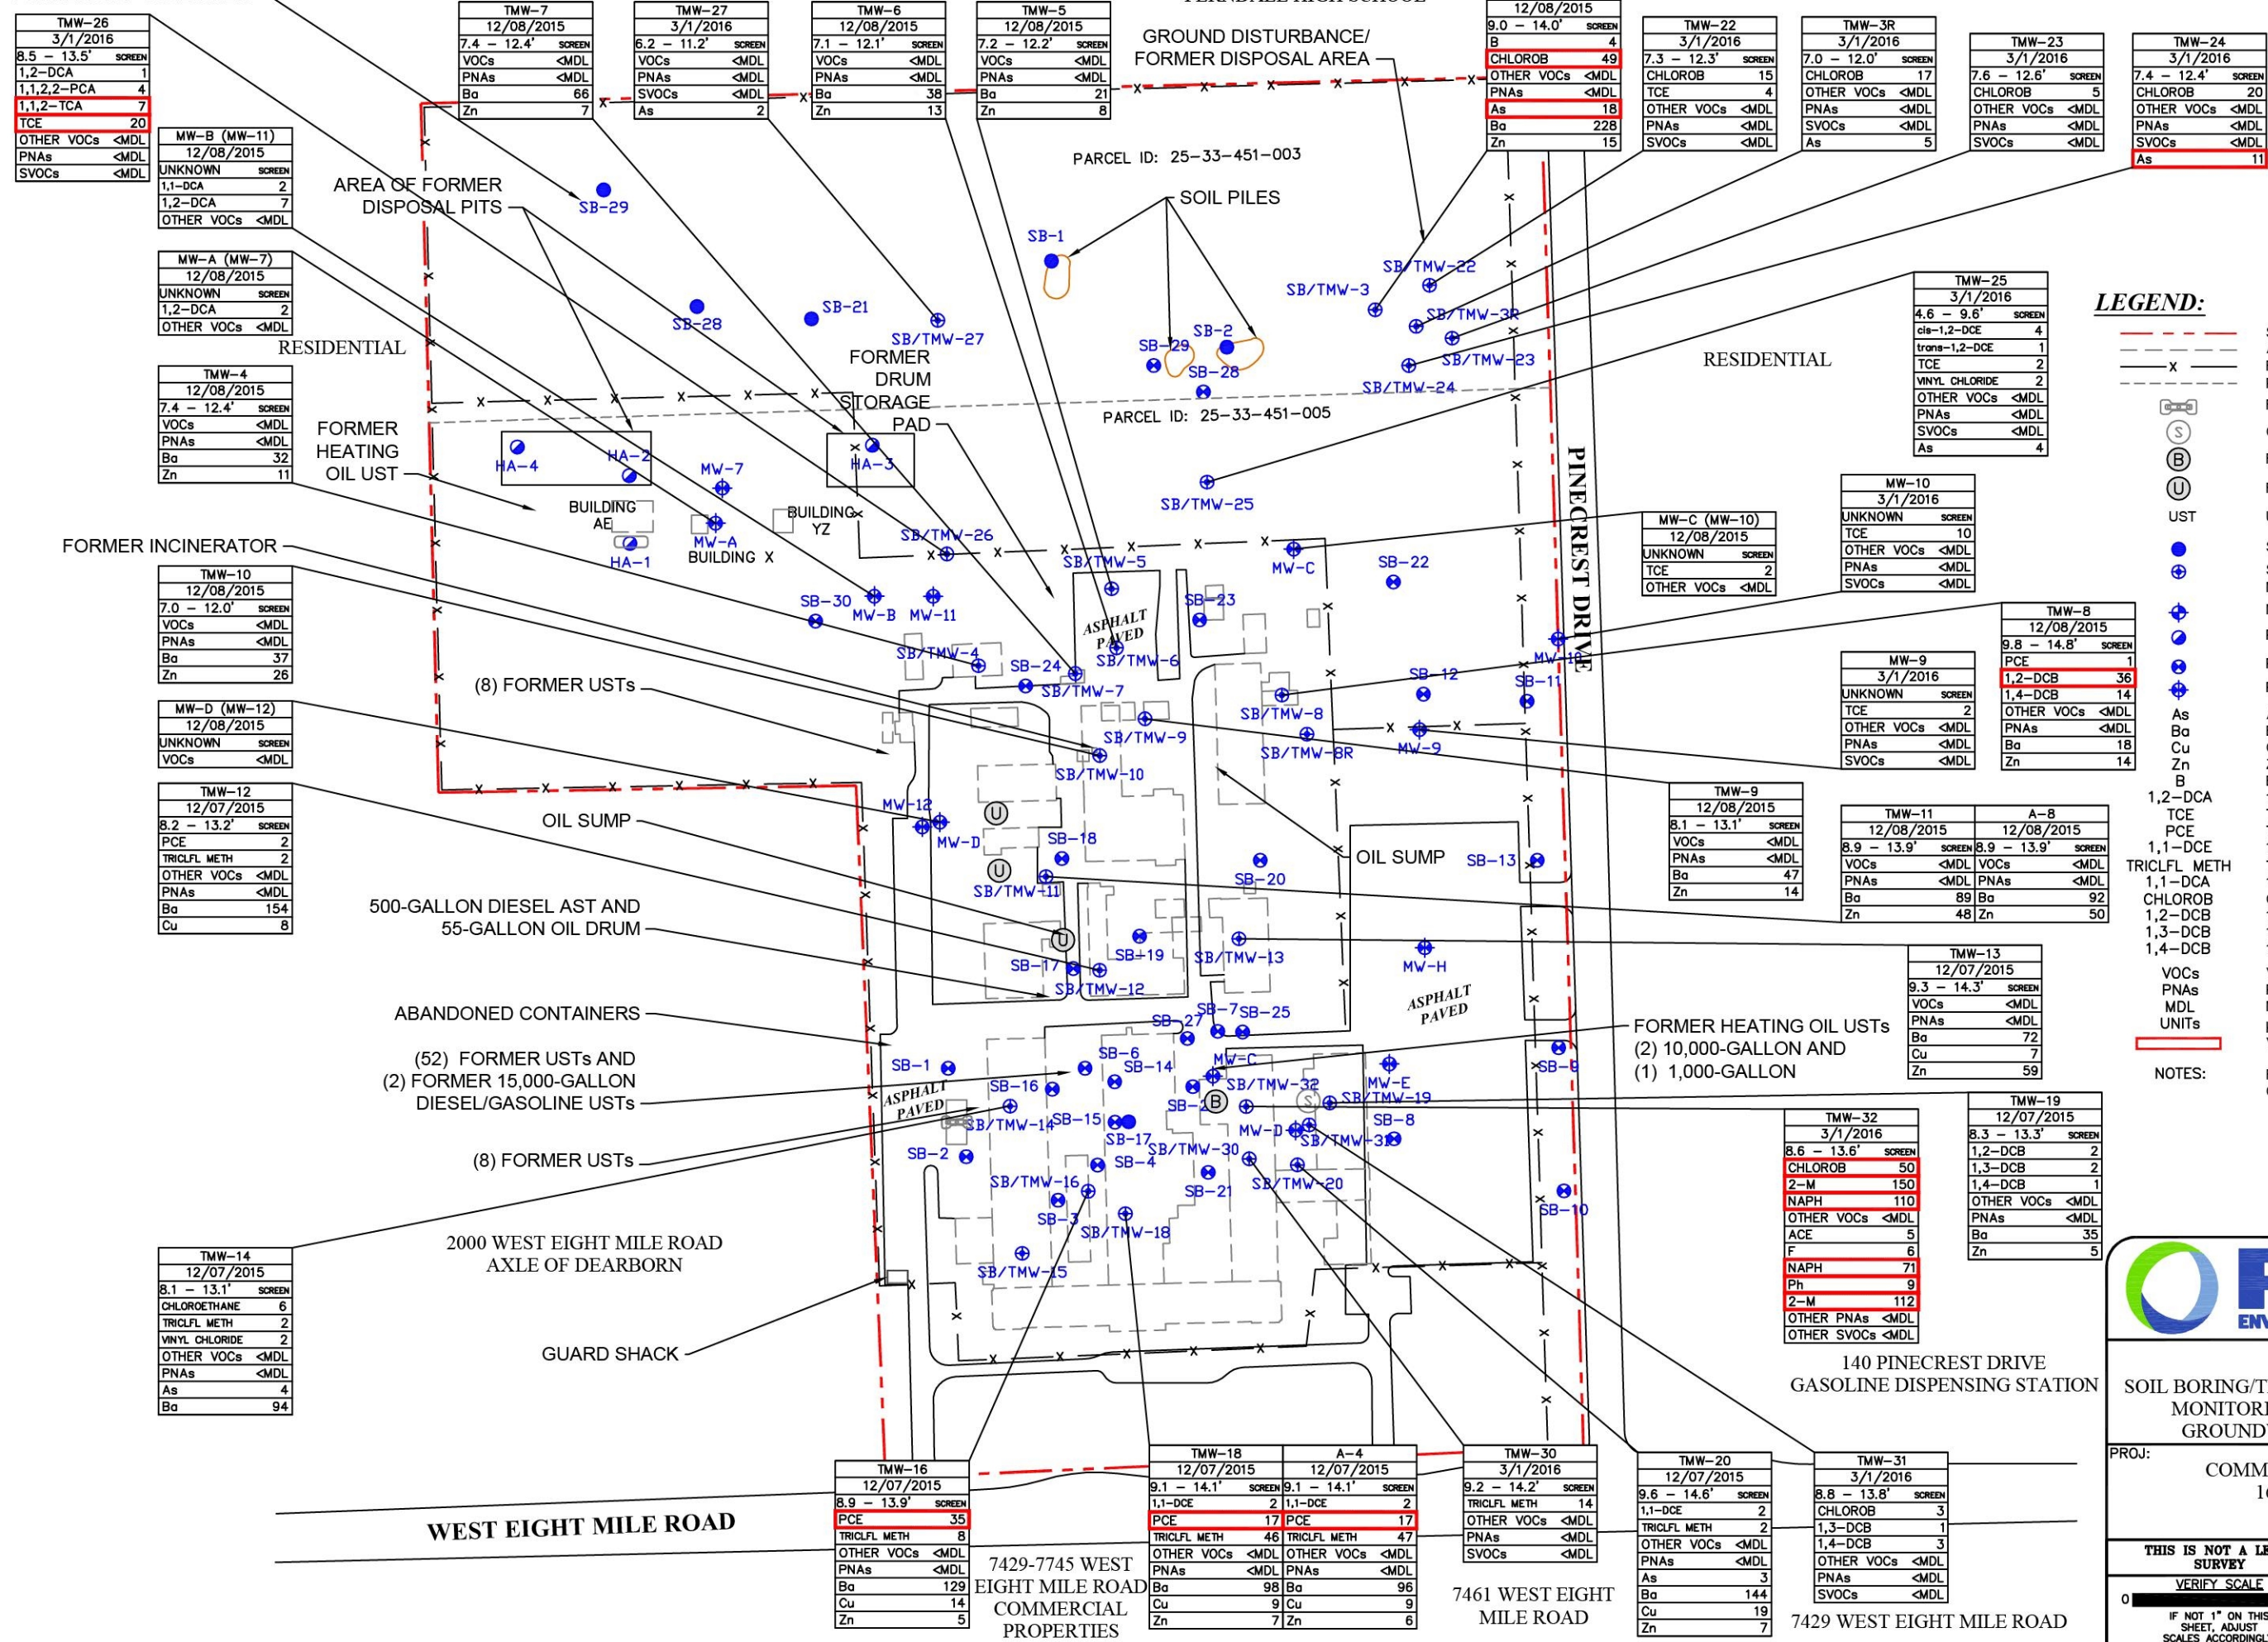
- SUBJECT PROPERTY
 - - - APPROXIMATE FORMER/HISTORICAL SITE FEATURE
 - - - FENCE
 - - - PARCEL / LOT BOUNDARIES
 - FORMER FUEL DISPENSER
 - COLLECTION SUMP

- UNITS μg/L (UNLESS NOTED)
 - VALUE EXCEEDS CRITERIA
- NOTES: REFER TO TABLES FOR SPECIFIC COMPOUNDS ANALYZED

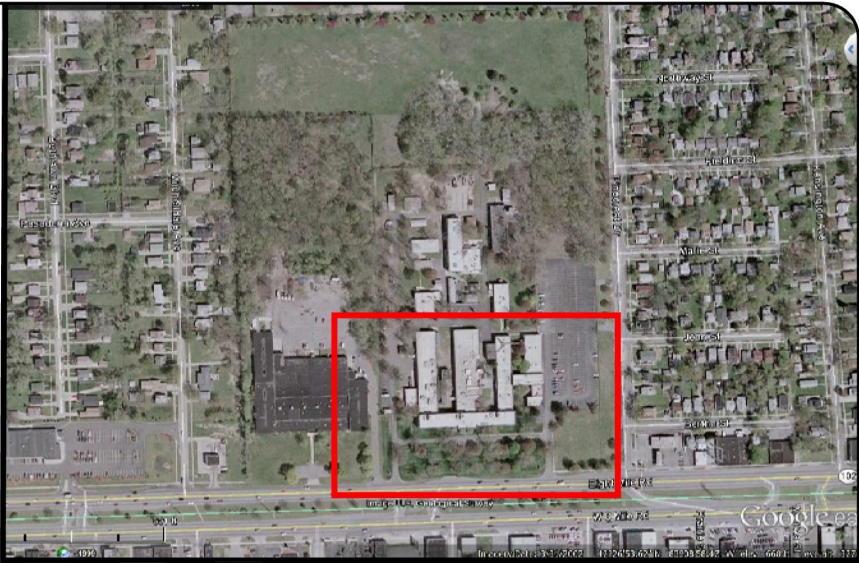
FIGURE 4
ZOOMED IN SECTION OF FORMER
SOUTHERN BUILDINGS

E	OFFICES, AUTO APP. DEPARTMENT
F	MAINTENANCE AND SERVICES
G	ANALYTICAL LAB
AL	VEHICLE FUELING
A	EXECUTIVE OFFICES
B	EXPERIMENT, MACHINE SHOP, GARAGE AND REF. TECHNICIAN
C	ENGINE RES. AND DYNAMOMETER
D	CHEMICAL LAB, LIBRARY, PHOTO AND FILES
DA	CHEMICAL RES., EXECUTIVE OFFICES AND PLANT
DAN	CHEMICAL RES. LAB
DAS	AUDITORIUM
BA	SHIPPING AND RECEIVING, AND COMPUTERS
H	FUEL BLENDING
Q	GUARD SHACK

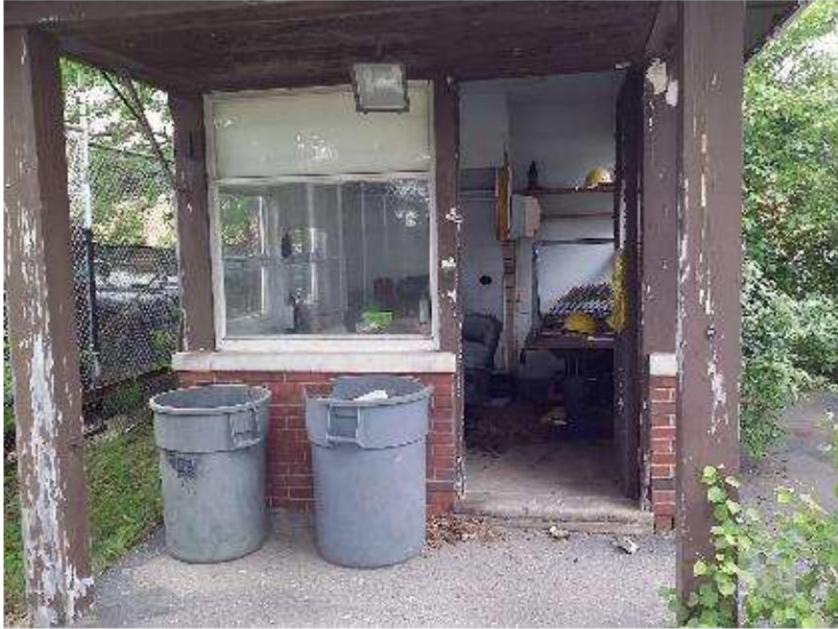
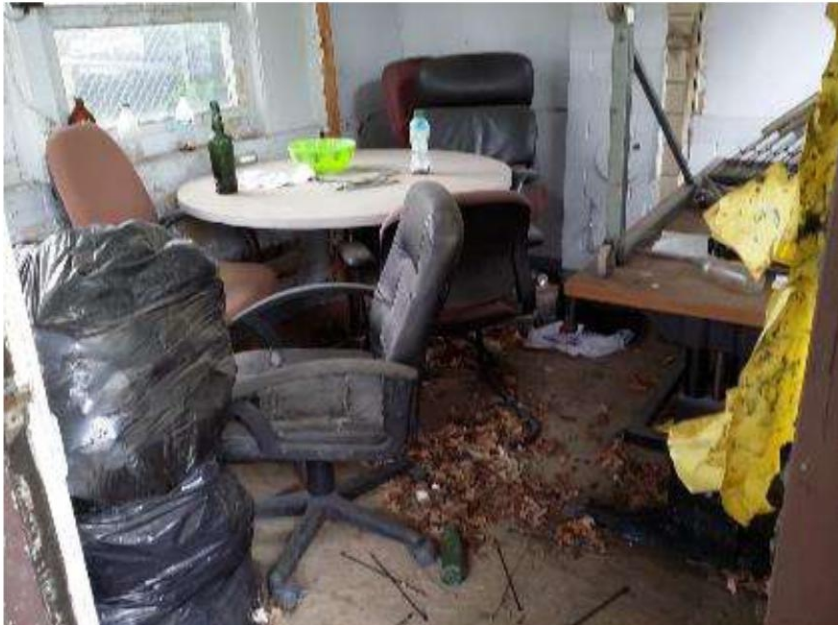
Photograph 7

The subject property contains an approximately 100 square foot guard house and a mobile trailer which are located in the southwestern portion of the property. The guard house is partially finished with a plywood floor, cinderblock walls, and a drywall ceiling. The guard house is on a poured concrete foundation. The mobile trailer is finished with 12 inch by 12 inch vinyl floor tiles, wood panel walls, and drywall ceilings.

Guard house

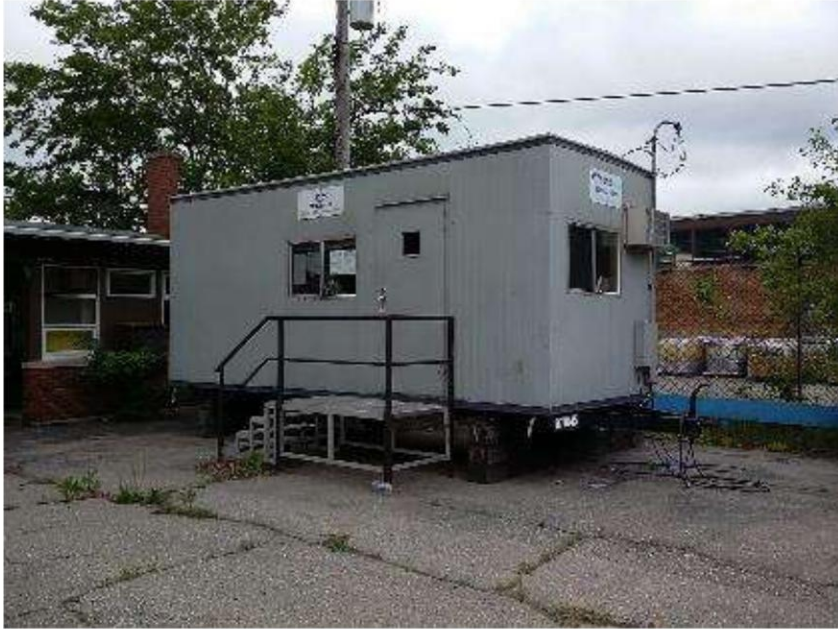
Photograph 9

Mobile trailer

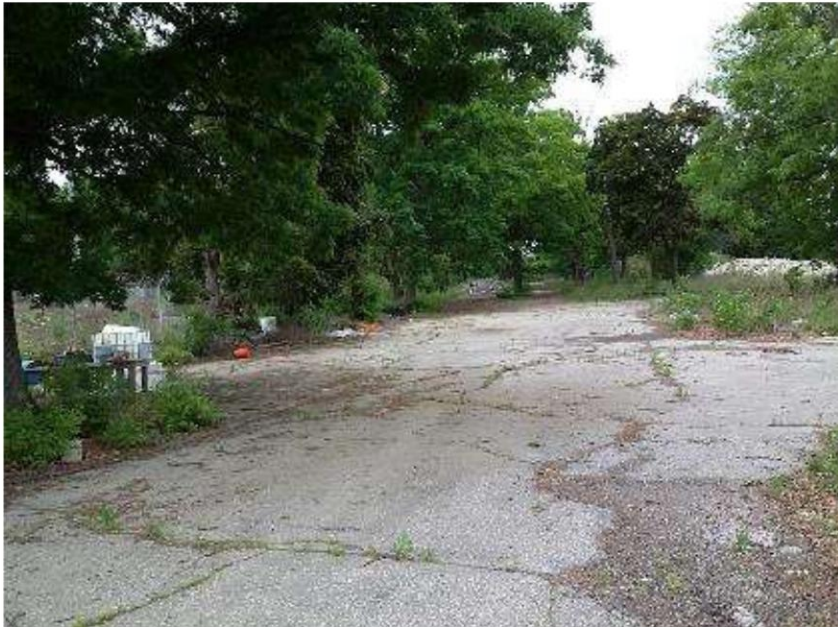
Photograph 10

Drums, Barrels, and/or Containers > 5-gallons: PM observed one 55-gallon drums and totes located in the western portion of the property that were not in secondary containment. Although some of the containers appeared to be empty, others appeared to contain unknown materials. The drums were stored on pavement or soil and appeared to be in good condition. An area of discoloration was observed on a portion of the pavement; however, the discoloration appeared to be due to organic materials and not petroleum based. Based on these observations, PM has not identified the containers as a REC. However, PM recommends the containers be properly disposed of in accordance with State and Federal regulations.

Abandoned containers and drums in the southwestern portion of the property
